**Flood Control Project Maintenance
Levee Inspections
LMA District Cover Sheet
Spring 2009 Levee Inspection Results**

San Joaquin County Flood Control District

Spring 2009 Levee Inspection Results

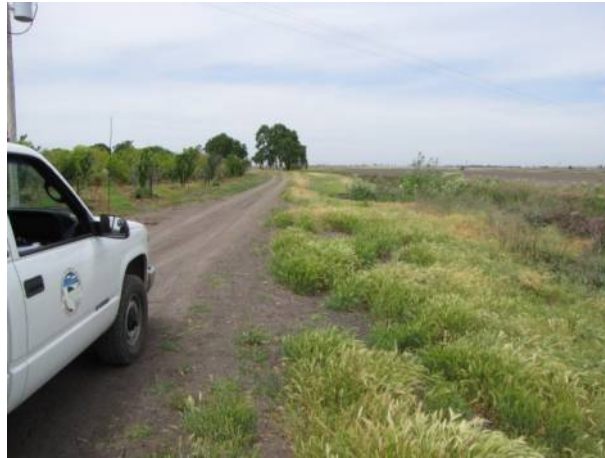
Levee Mile Report Line	2
Start Levee Mile	0.32
End Levee Mile	1.00
Location	Water Side
Category	Earthen Levee
Item	Vegetation
Control annual grass along waterside of levee from LM 0.32 to LM 1.00.

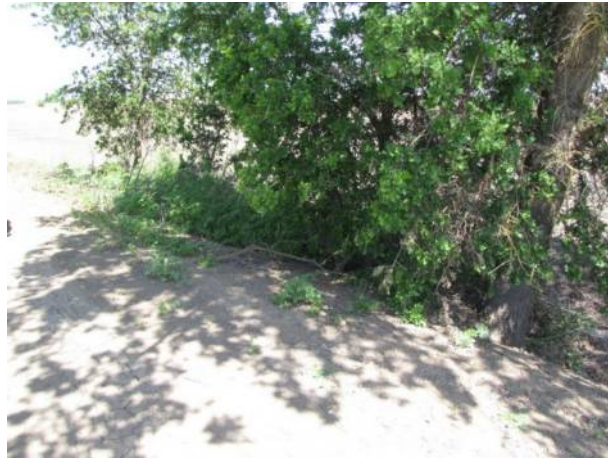
Levee Mile Report Line	1
Start Levee Mile	1.10
End Levee Mile	1.10
Location	Land Side
Category	Earthen Levee
Item	Trim / Thin Trees
Trim trees to allow for visibility and access.

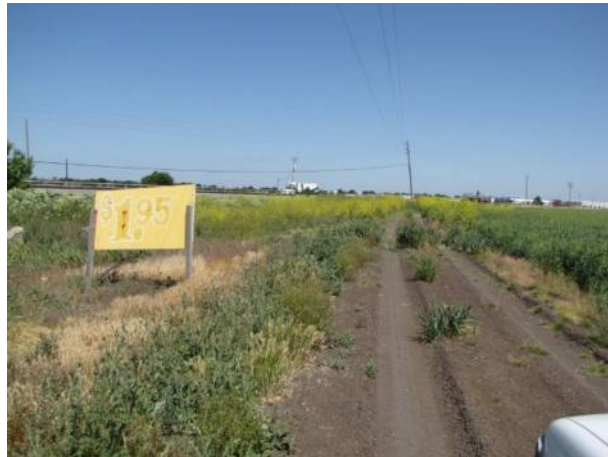
Levee Mile Report Line	3
Start Levee Mile	1.80
End Levee Mile	1.88
Location	Crown
Category	Earthen Levee
Item	Vegetation
Remove/mow vegetation and grass along crown of levee/access road.

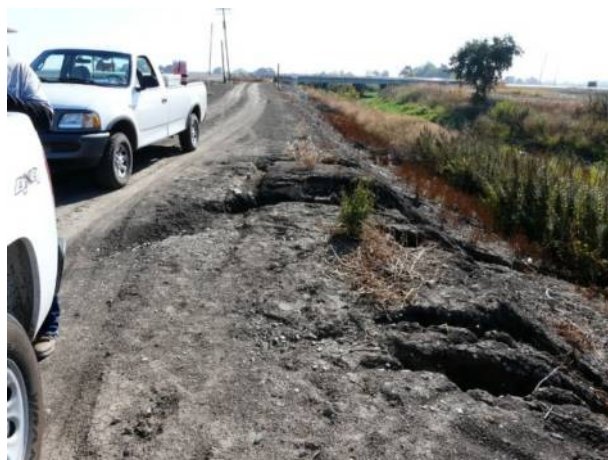
Levee Mile Report Line	4
Start Levee Mile	1.90
End Levee Mile	1.90
Location	Water Side
Category	Earthen Levee
Item	Erosion / Bank Caving
Repair & compact erosion caused by farmer on waterward slope at LM 1.90

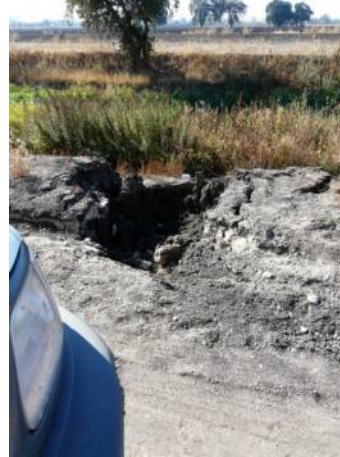
Levee Mile Report Line	4
Start Levee Mile	1.90
End Levee Mile	1.90
Location	Water Side
Category	Earthen Levee
Item	Erosion / Bank Caving
Repair & compact erosion caused by farmer on waterward slope at LM 1.90.

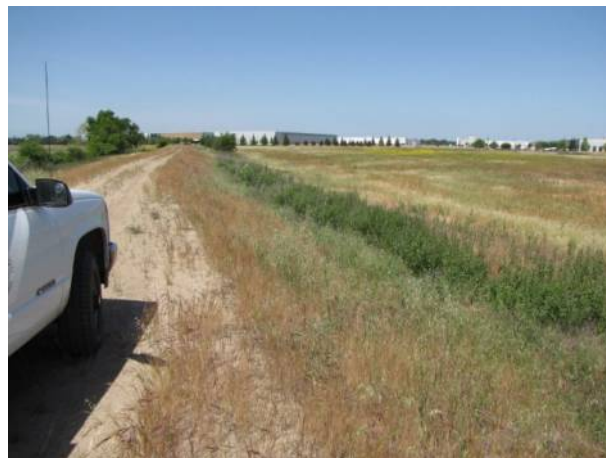
Levee Mile Report Line	8
Start Levee Mile	2.60
End Levee Mile	3.24
Location	Land Side
Category	Earthen Levee
Item	Vegetation
Remove/mow grass & vegetation along landward slope of levee and within 10' of the toe.

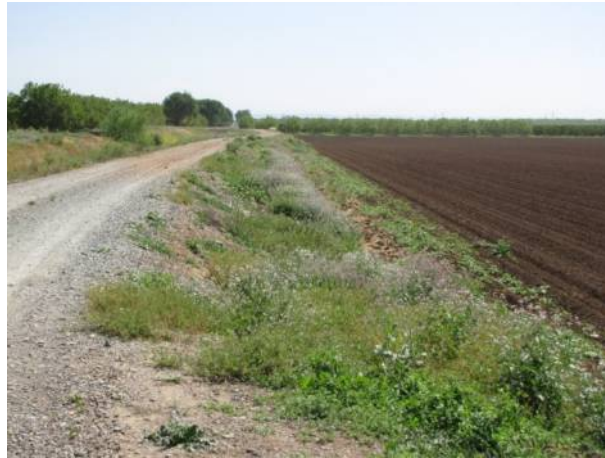
Levee Mile Report Line	1
Start Levee Mile	0.00
End Levee Mile	0.23
Location	Land Side
Category	Earthen Levee
Item	Vegetation
Control annual grass & weeds along landside of levee from LM 0.00 to LM 0.23.

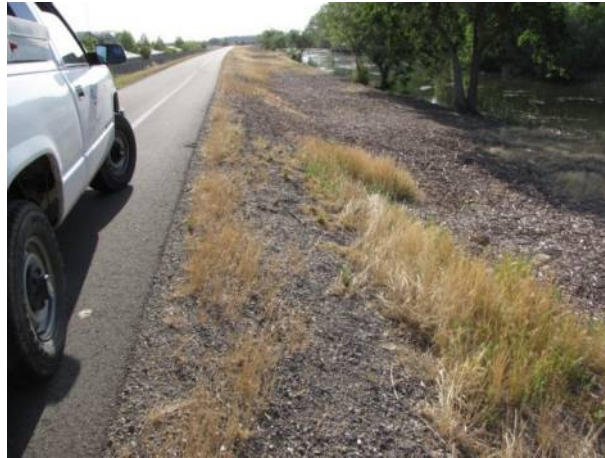
Levee Mile Report Line	1
Start Levee Mile	0.00
End Levee Mile	0.18
Location	Water Side
Category	Earthen Levee
Item	Vegetation
Remove/mow grass & vegetation along waterward slope of levee.

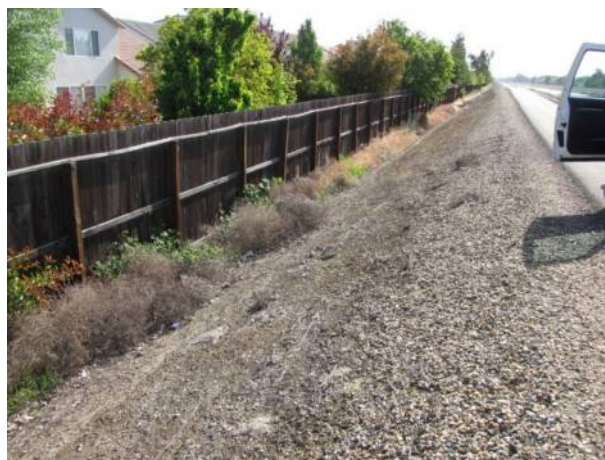
Levee Mile Report Line	3
Start Levee Mile	0.78
End Levee Mile	1.55
Location	Land Side
Category	Earthen Levee
Item	Vegetation
Remove/mow grass & vegetation along landward slope of levee and 10' from toe.

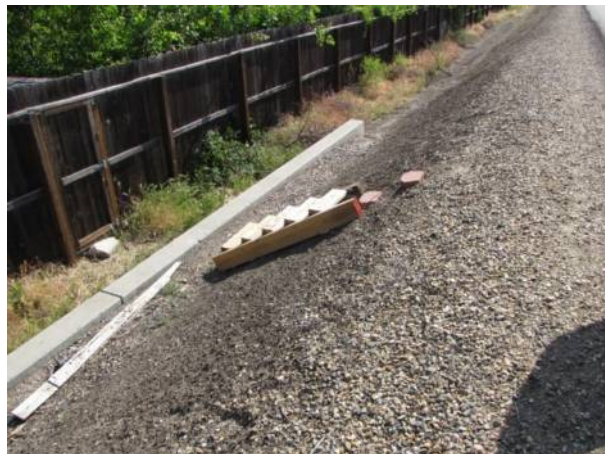
Levee Mile Report Line	5
Start Levee Mile	0.83
End Levee Mile	0.83
Location	Land Side
Category	Earthen Levee
Item	Encroachments
Stairs on landward slope of levee.

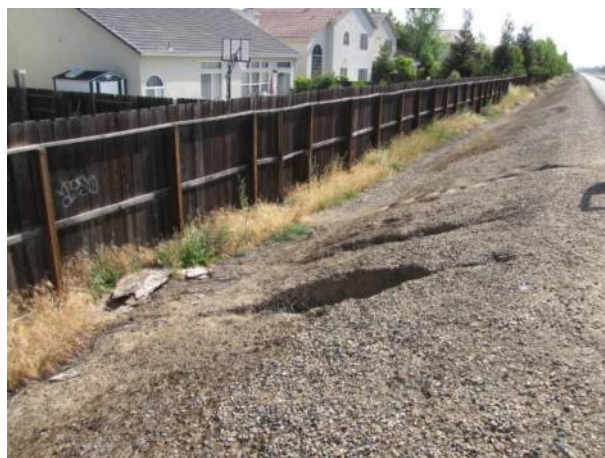
Levee Mile Report Line	6
Start Levee Mile	0.91
End Levee Mile	0.91
Location	Land Side
Category	Earthen Levee
Item	Erosion / Bank Caving
Repair erosion on landward slope of levee.

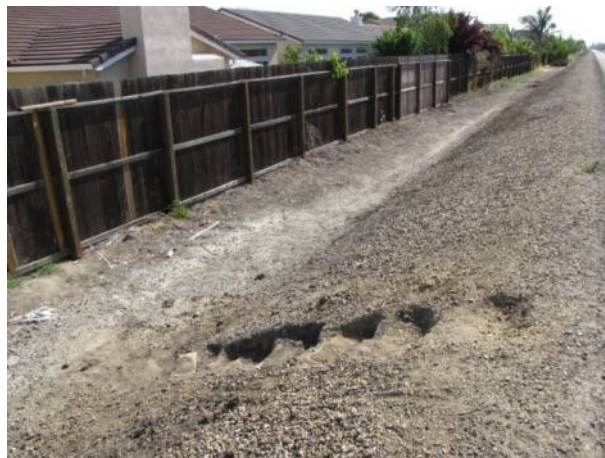
Steps dug into landward slope of levee. Backfill and recompact the slope.

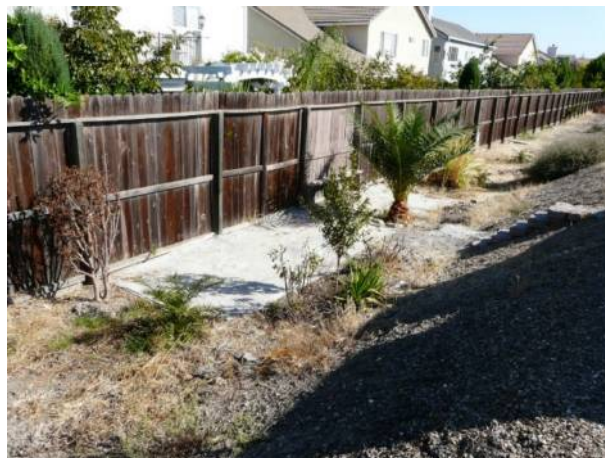
Levee Mile Report Line	12
Start Levee Mile	1.45
End Levee Mile	1.45
Location	Land Side
Category	Earthen Levee
Item	Encroachments
Landscaping located within 10' from landside toe of levee at LM 1.45.

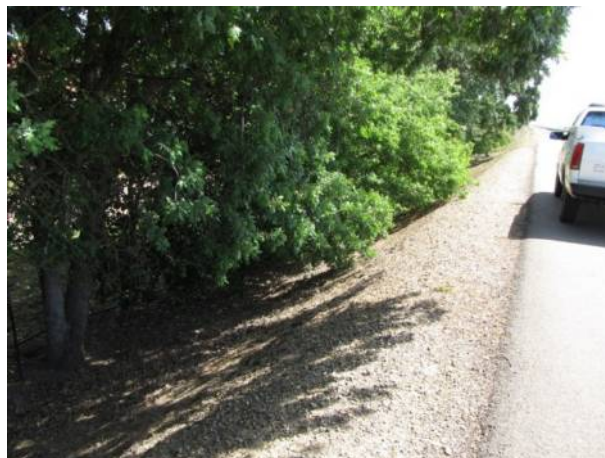
Trim trees to allow for visibility of landward slope of levee.

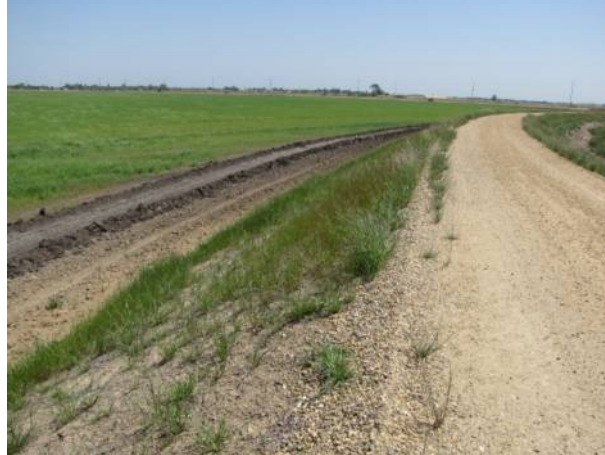
Levee Mile Report Line	26
Start Levee Mile	4.38
End Levee Mile	4.60
Location	Land Side
Category	Earthen Levee
Item	Vegetation
Remove/mow grass & vegetation along landward slope of levee and within 10' of toe.

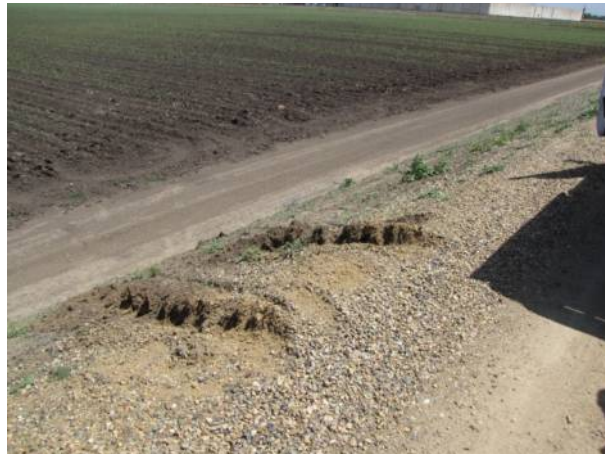
Levee Mile Report Line	29
Start Levee Mile	5.70
End Levee Mile	5.70
Location	Land Side
Category	Earthen Levee
Item	Slope Stability
Repair damage due to vehicular traffic on landward slope of levee.

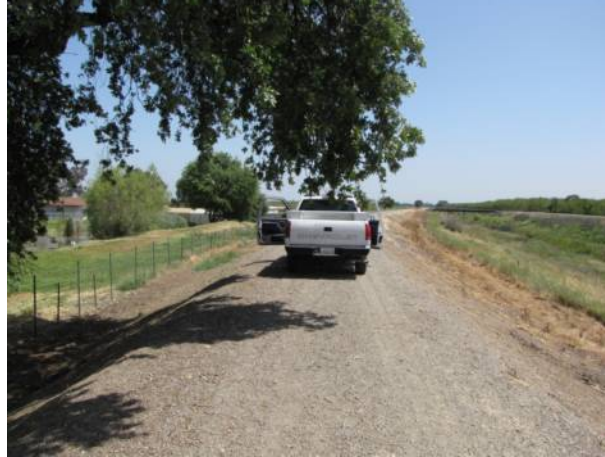
Levee Mile Report Line	33
Start Levee Mile	8.09
End Levee Mile	8.09
Location	Crown
Category	Earthen Levee
Item	Trim / Thin Trees
Trim trees over roadway to allow for vehicular traffic.

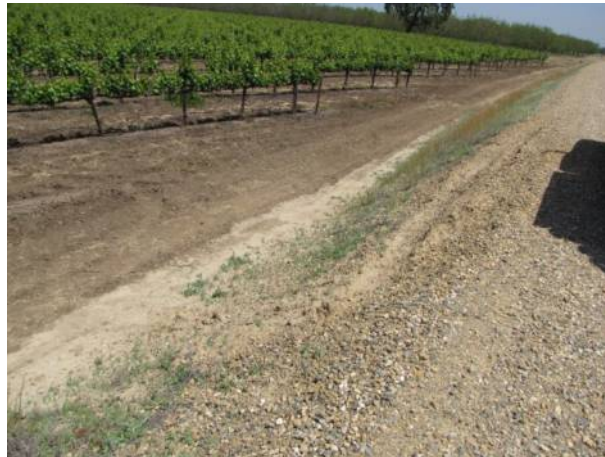
Levee Mile Report Line	34
Start Levee Mile	8.70
End Levee Mile	8.70
Location	Land Side
Category	Earthen Levee
Item	Slope Stability
Repair damage caused by vehicular traffic on landward slope of levee.

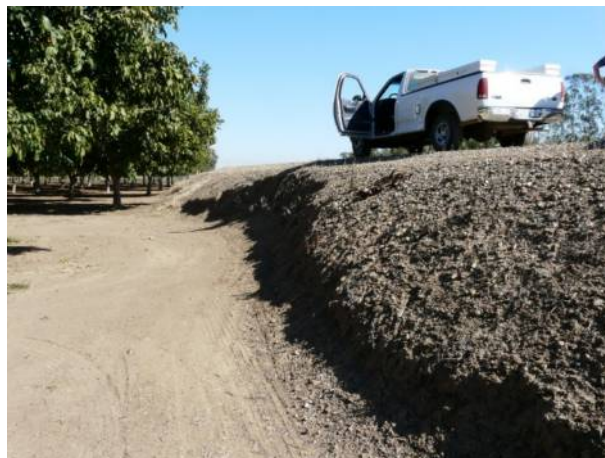
Levee Mile Report Line	40
Start Levee Mile	9.95
End Levee Mile	9.95
Location	Land Side
Category	Earthen Levee
Item	Slope Stability
Significant amount of landside levee slope removed and damaged by farm equipment at LM 9.95. Repair levee and attempt to prevent future damage.

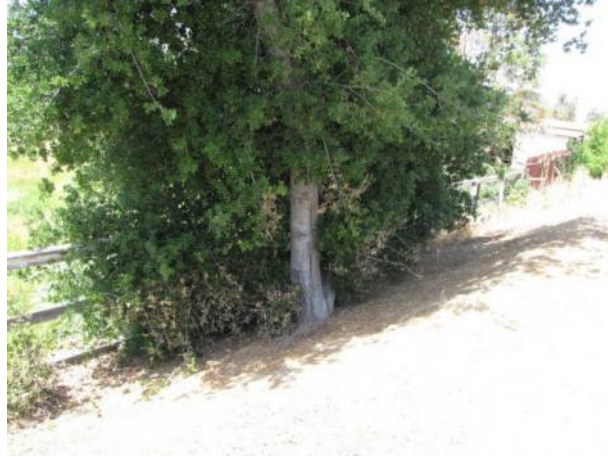
Levee Mile Report Line	43
Start Levee Mile	10.42
End Levee Mile	10.42
Location	Land Side
Category	Earthen Levee
Item	Trim / Thin Trees
Trim tree to allow for visibility of landward levee slope.

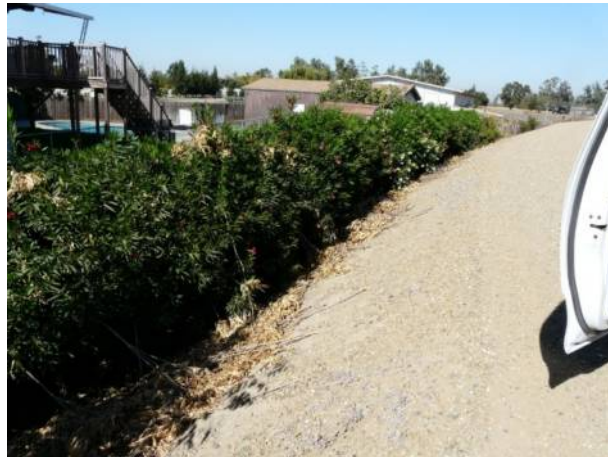
Levee Mile Report Line	44
Start Levee Mile	10.44
End Levee Mile	10.46
Location	Land Side
Category	Earthen Levee
Item	Encroachments
Landscaping located within 10' from landside toe of levee from LM 10.44 to LM 10.46.

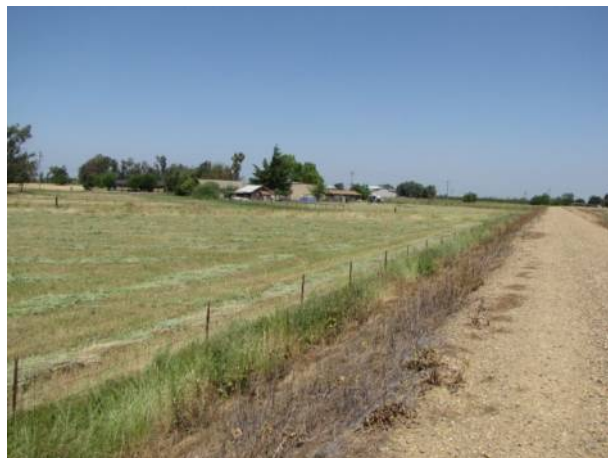
Levee Mile Report Line	45
Start Levee Mile	10.59
End Levee Mile	10.92
Location	Land Side
Category	Earthen Levee
Item	Vegetation
Remove/mow grass & vegetation within 10' of landward toe of levee..

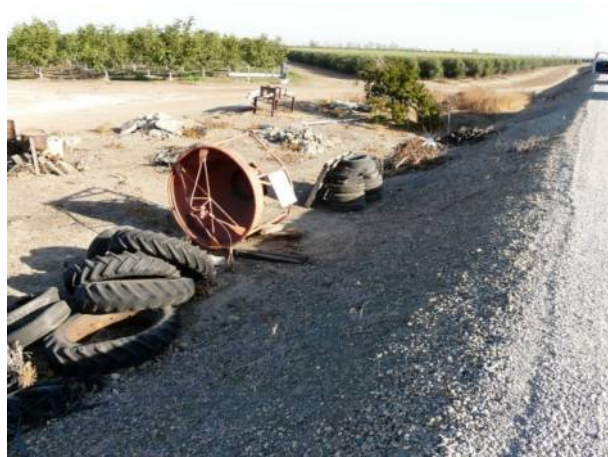
Levee Mile Report Line	46
Start Levee Mile	10.95
End Levee Mile	10.96
Location	Land Side
Category	Earthen Levee
Item	Encroachments
Debris located along landside toe of levee from LM 10.95 to LM 10.96.

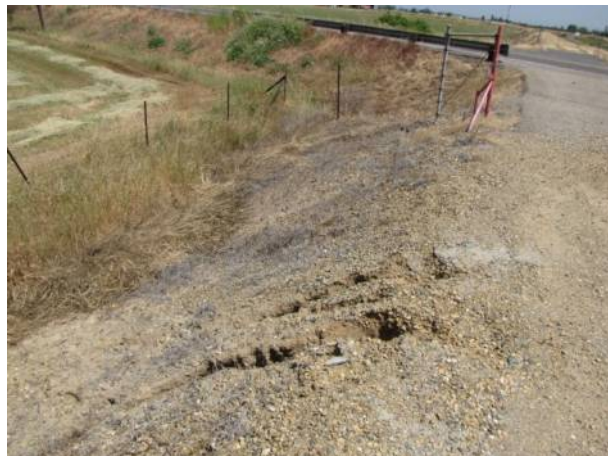
Levee Mile Report Line	47
Start Levee Mile	12.42
End Levee Mile	12.42
Location	Land Side
Category	Earthen Levee
Item	Erosion / Bank Caving
Repair erosion along landward slope of levee.

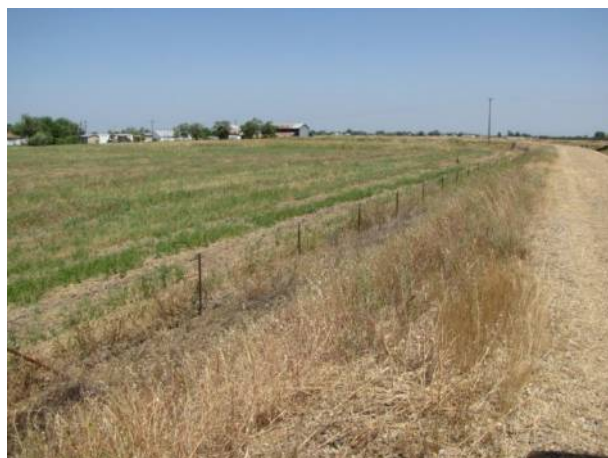
Levee Mile Report Line	48
Start Levee Mile	12.52
End Levee Mile	12.56
Location	Land Side
Category	Earthen Levee
Item	Vegetation
Remove/mow grass & vegetation along landward slope of levee and within 10' of the toe.

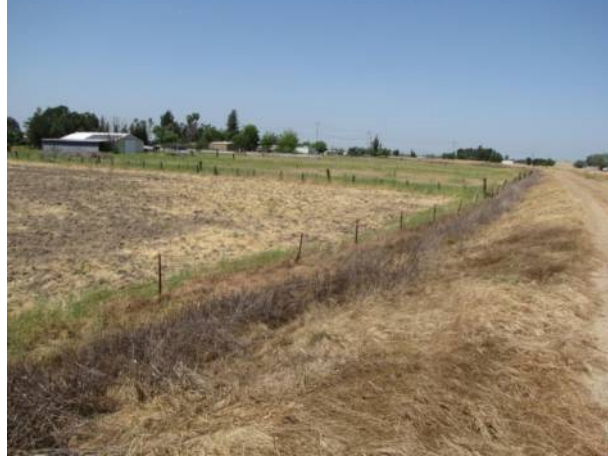
Levee Mile Report Line	51
Start Levee Mile	12.95
End Levee Mile	13.19
Location	Land Side
Category	Earthen Levee
Item	Vegetation
Remove/mow grass & vegetation along landward slope of levee and within 10' of the toe.

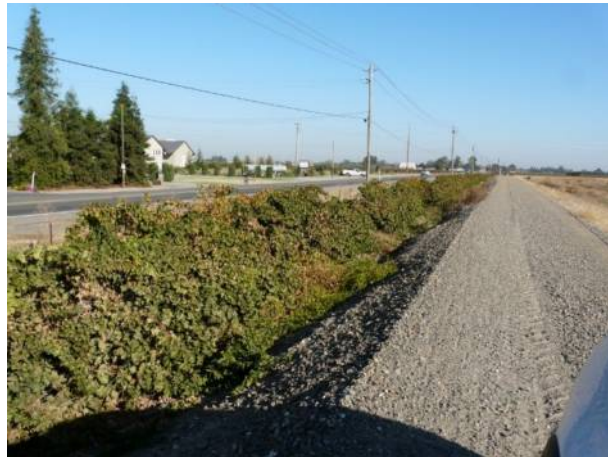
Levee Mile Report Line	53
Start Levee Mile	13.39
End Levee Mile	13.51
Location	Land Side
Category	Earthen Levee
Item	Encroachments
Grape vines within 10' from landside toe of levee from LM 13.39 to 13.51.

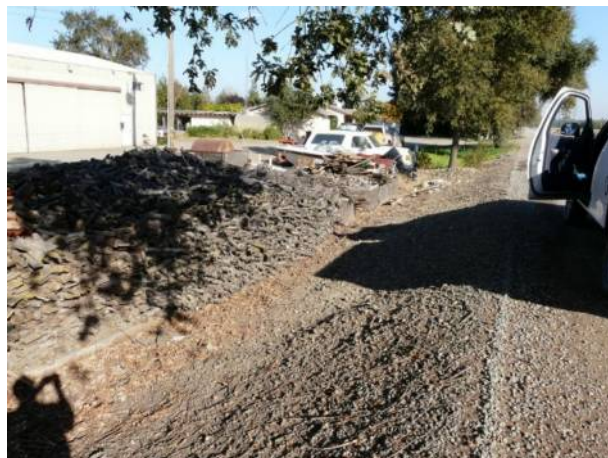
Levee Mile Report Line	56
Start Levee Mile	14.08
End Levee Mile	14.08
Location	Land Side
Category	Earthen Levee
Item	Encroachments
Move firewood to outside of 10' from landside toe of levee at LM 14.08.

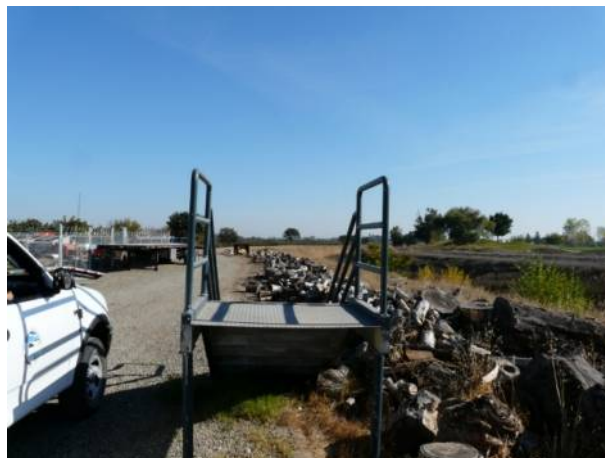
Debris located on waterside shoulder of access road next to golf course maintenance yard from LM 15.58 to 15.63. Debris should be moved to allow for patrolling next to channel and for visibility.

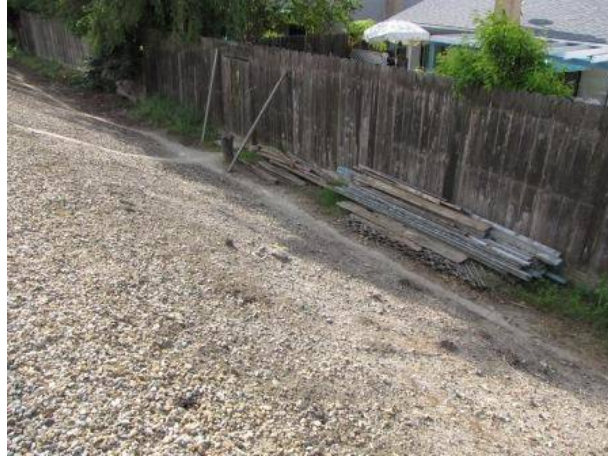
Levee Mile Report Line	1
Start Levee Mile	1.14
End Levee Mile	1.14
Location	Land Side
Category	Earthen Levee
Item	Encroachments
Remove debris within 10' of landward toe of levee.

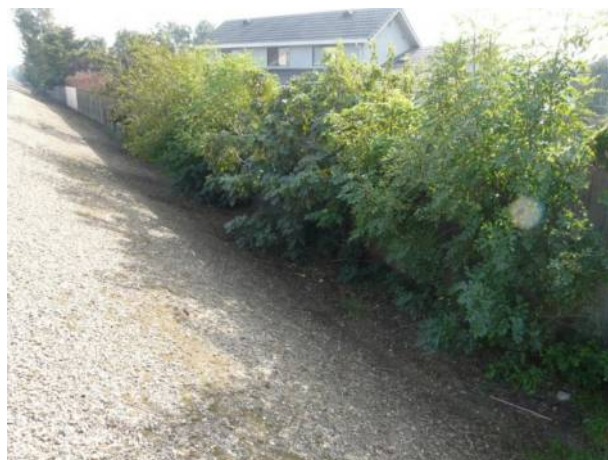
Levee Mile Report Line	4
Start Levee Mile	1.27
End Levee Mile	1.27
Location	Land Side
Category	Earthen Levee
Item	Encroachments
Landscaping along landside toe of levee at LM 1.27

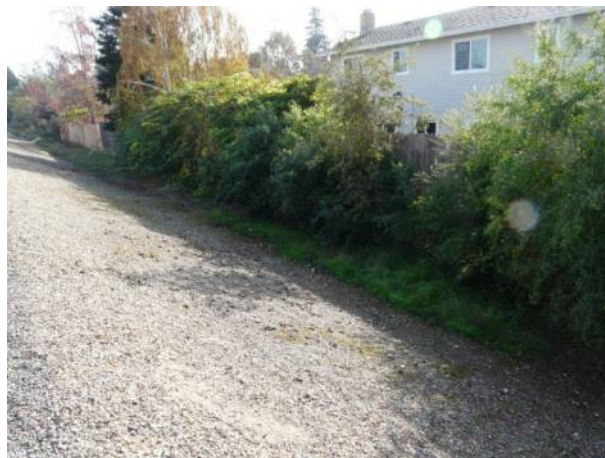
Levee Mile Report Line	9
Start Levee Mile	1.67
End Levee Mile	1.67
Location	Land Side
Category	Earthen Levee
Item	Encroachments
Landscaping along toe of landside of levee at LM 1.67

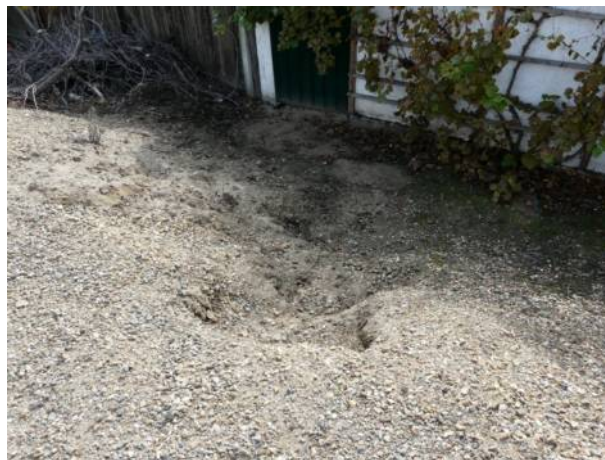
Levee Mile Report Line	37
Start Levee Mile	3.00
End Levee Mile	3.00
Location	Land Side
Category	Earthen Levee
Item	Slope Stability

Repair landside slope of levee where damaged by foot traffic at LM 3.00

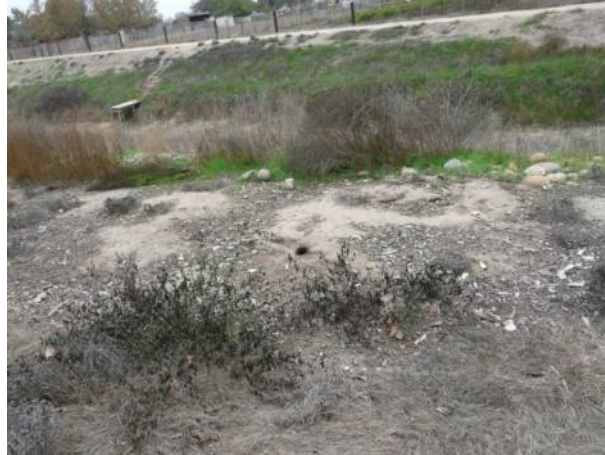
Example of rodent hole needing to be repaired along waterside of levee from LM 15.14 to LM 15.15

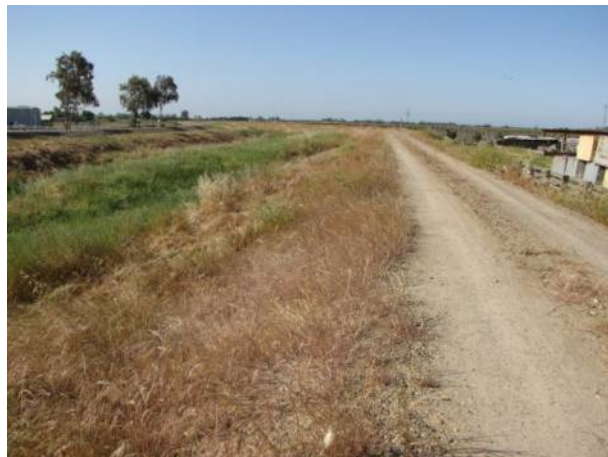
Levee Mile Report Line	2
Start Levee Mile	0.00
End Levee Mile	0.46
Location	Water Side
Category	Earthen Levee
Item	Vegetation
Remove/mow grass & vegetation along top 20' of waterward levee slope.

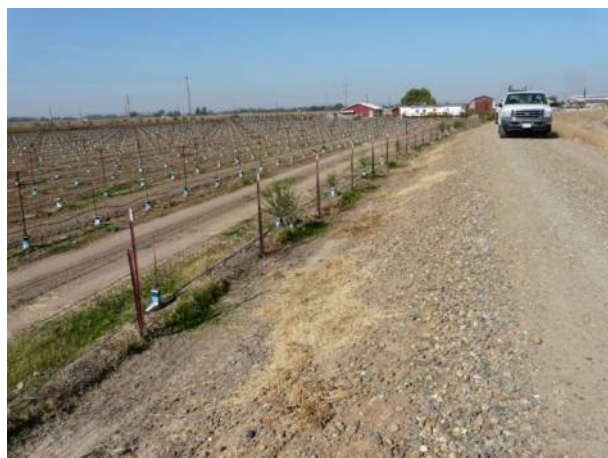
Levee Mile Report Line	3
Start Levee Mile	0.17
End Levee Mile	0.49
Location	Land Side
Category	Earthen Levee
Item	Encroachments
Fence located from LM 0.17 to LM 0.49 and crops located from LM 0.17 to LM 0.41 within 10' from landside toe of levee.

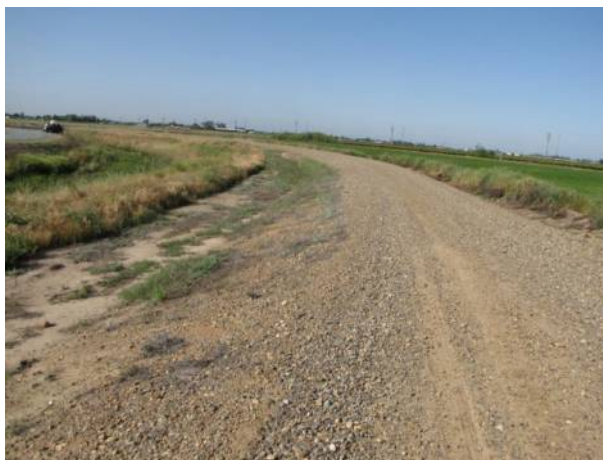
Example of condition of this levee. The unit is well maintained for vegetation.

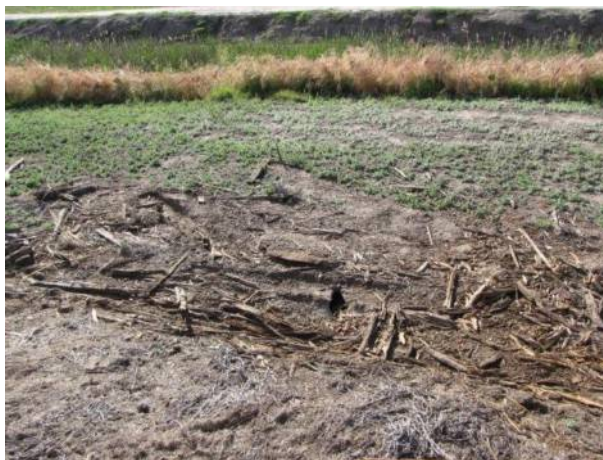
Levee Mile Report Line	8
Start Levee Mile	3.17
End Levee Mile	3.17
Location	Water Side
Category	Earthen Levee
Item	Animal Control

The debris pile previously noted has been removed, but there are rodent holes under the pile. Backfill and compact the rodent holes.

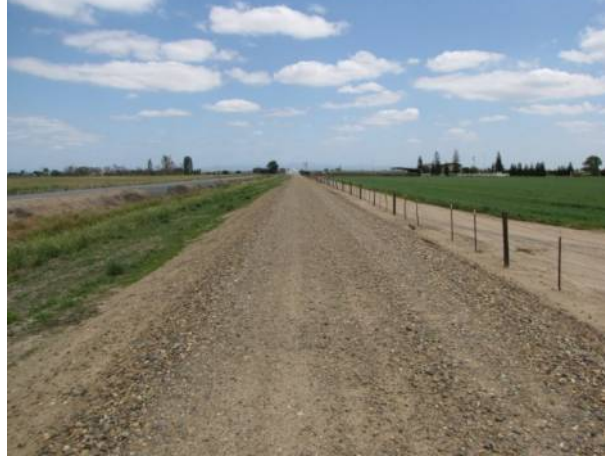
Example of condition of the crown of the levee.
This unit is well maintained.

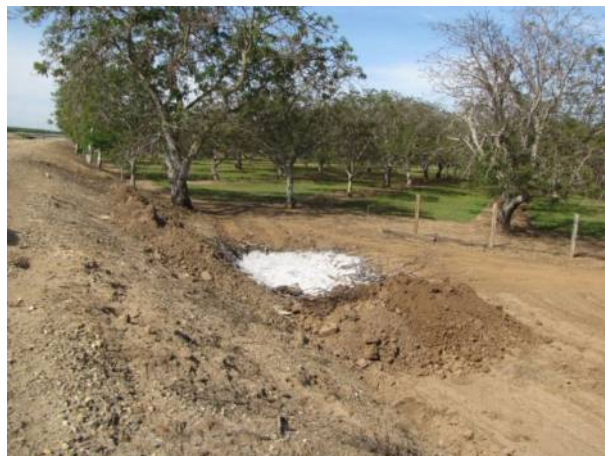
Levee Mile Report Line	10
Start Levee Mile	2.61
End Levee Mile	2.61
Location	Land Side
Category	Earthen Levee
Item	Slope Stability
Landowner had dug into the toe of the levee for the burn pile. Remove the debris and recompact the excavation at LM 2.61 on the landward side of the levee.

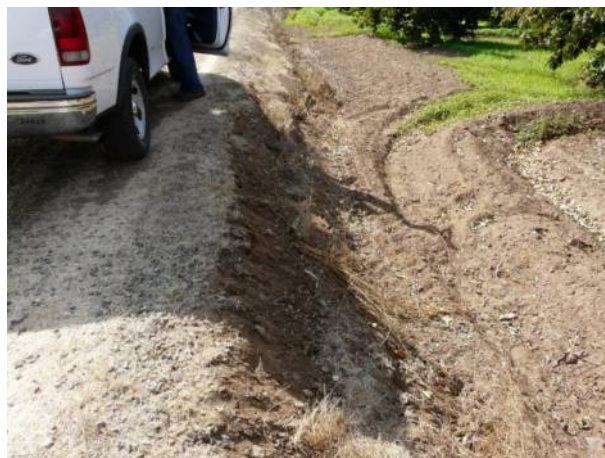
Levee Mile Report Line	61
Start Levee Mile	6.75
End Levee Mile	6.88
Location	Land Side
Category	Earthen Levee
Item	Erosion / Bank Caving
Farming equipment grading into the landside toe of the levee located at LM 6.90. Backfill and compact to design shape and attempt to prevent future damage.

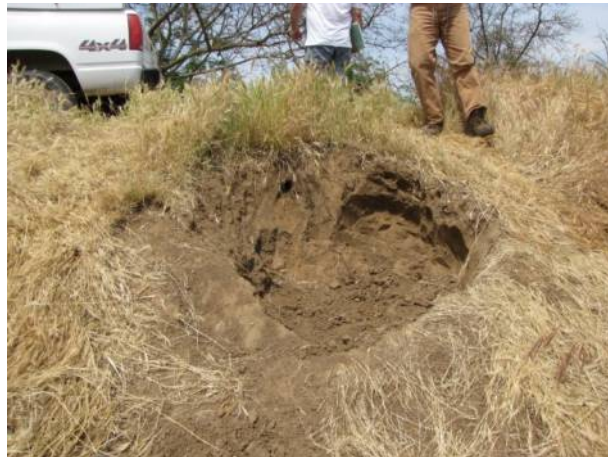
Levee Mile Report Line	77
Start Levee Mile	8.46
End Levee Mile	8.46
Location	Water Side
Category	Earthen Levee
Item	Erosion / Bank Caving
Recompact and backfill hole dug into waterward slope of levee.

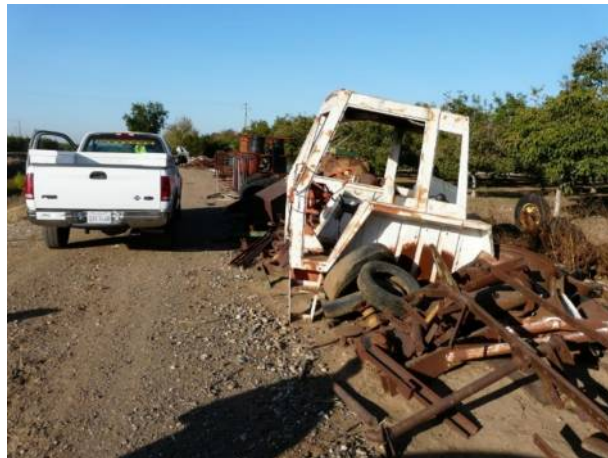
Levee Mile Report Line	80
Start Levee Mile	8.68
End Levee Mile	8.70
Location	Land Side
Category	Earthen Levee
Item	Encroachments
Remove equipment from landside slope of levee at from LM 8.68 to LM 8.70.

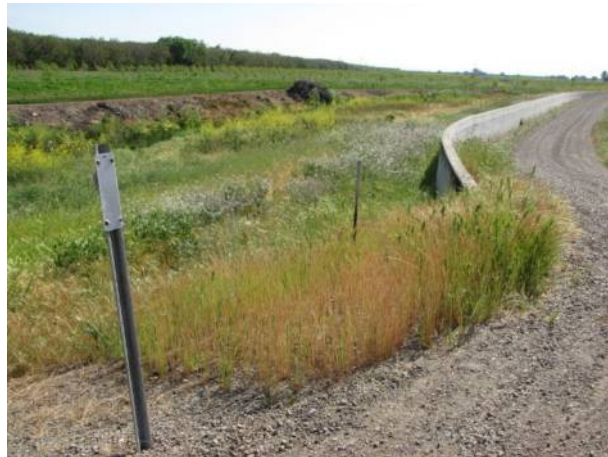
Levee Mile Report Line	2
Start Levee Mile	0.10
End Levee Mile	0.50
Location	Water Side
Category	Earthen Levee
Item	Vegetation
Control annual grass & weeds along waterside of levee from LM 0.10 to LM 0.50.
